Surf House Weekly AMTS Monitoring Report

For Fort Partners

07/14/2023 to 07/24/2023

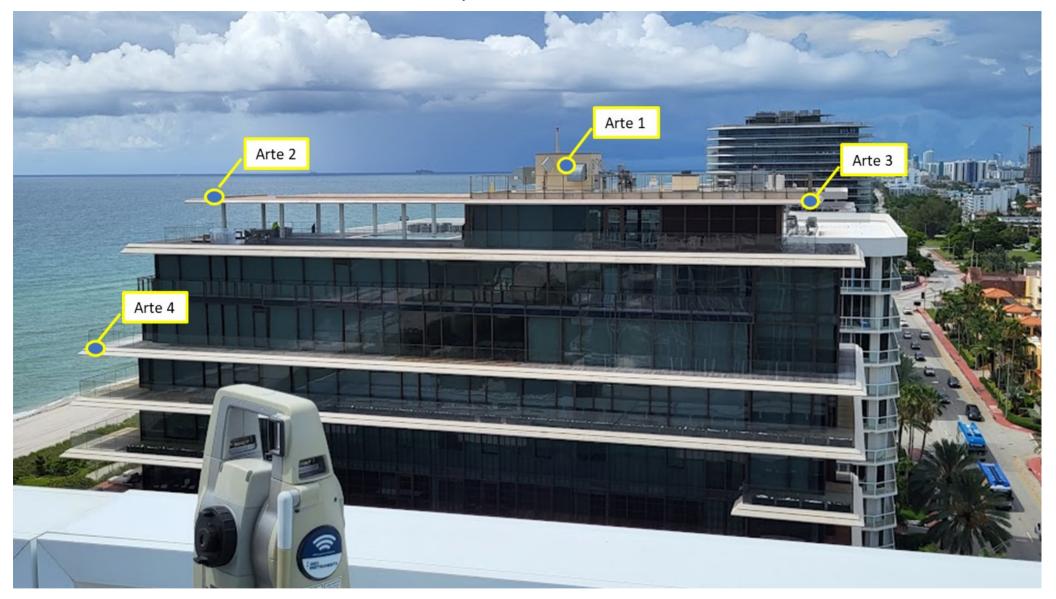
Report AMTS View

A total of four (4) have been installed at this time. The system collects readings every hour on the monitoring points on the Arte building. The location and identification of each device is presented in the table below and shown graphically on the map. A graph will be displayed for each monitor showing the data points collected during the specified time period. This report will display the average daily data collected from the week of this report.

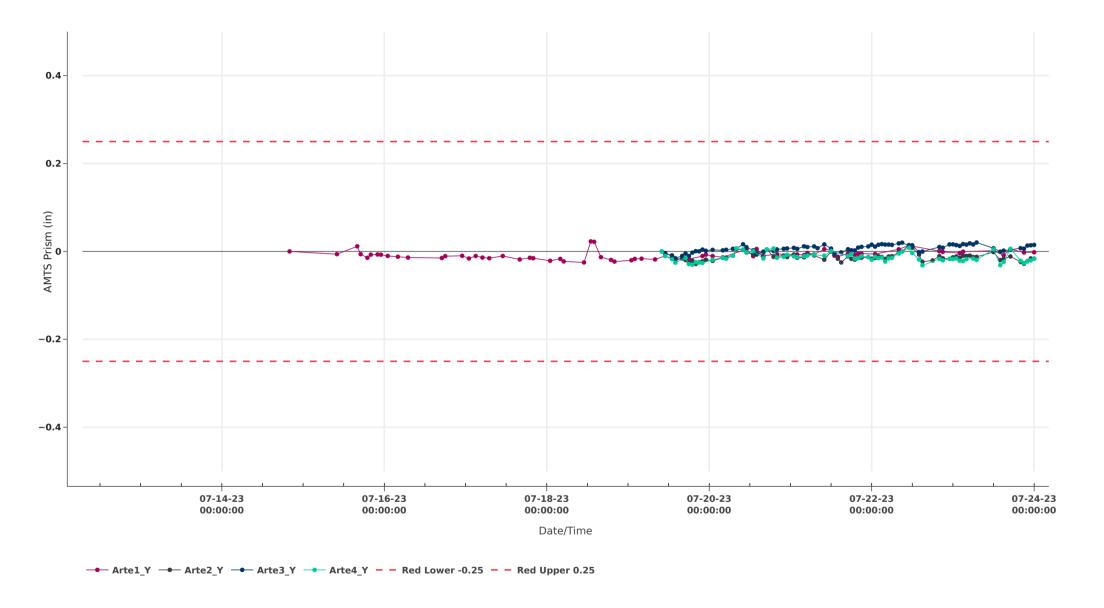
Surf House : Surf House AMTS Report 07/24/2023

AMTS X-Axis Readings - Average Daily Values (Change in Inches)				
Date	Arte1	Arte2	Arte3	Arte4
7/15/2023	-0.026			
7/16/2023	-0.017			
7/17/2023	-0.025			
7/18/2023	-0.021			
7/19/2023	-0.007	0.024	-0.025	-0.005
7/20/2023	0.007	0.021	-0.024	0.003
7/21/2023	-0.007	0.008	-0.031	-0.008
7/22/2023	-0.006	-0.005	-0.033	-0.016
7/23/2023	-0.007	0.004	-0.032	-0.006

AMTS Y-Axis Readings - Average Daily Values (Change in Inches)				
Date	Arte1	Arte2	Arte3	Arte4
7/15/2023	-0.005			
7/16/2023	-0.012			
7/17/2023	-0.014			
7/18/2023	-0.011			
7/19/2023	-0.015	-0.018	-0.004	-0.020
7/20/2023	-0.006	-0.008	0.004	-0.006
7/21/2023	-0.005	-0.013	0.007	-0.010
7/22/2023	0.002	-0.010	0.013	-0.014
7/23/2023	-0.001	-0.015	0.011	-0.018

AMTS Z-Axis Readings - Average Daily Values (Change in Inches)				
Date	Arte1	Arte2	Arte3	Arte4
7/15/2023	0.001			
7/16/2023	0.001			
7/17/2023	0.000			
7/18/2023	0.018			
7/19/2023	0.002	0.020	0.004	0.008
7/20/2023	0.017	0.013	-0.005	0.017
7/21/2023	0.008	0.015	-0.008	0.011
7/22/2023	0.010	0.019	-0.007	0.014
7/23/2023	0.009	0.020	-0.009	0.016
